How Did the Bicyclist Cross the Road? A Case Study of 2 Traffic Signals in Seattle

By Mike Hendrix, PE, PTOE

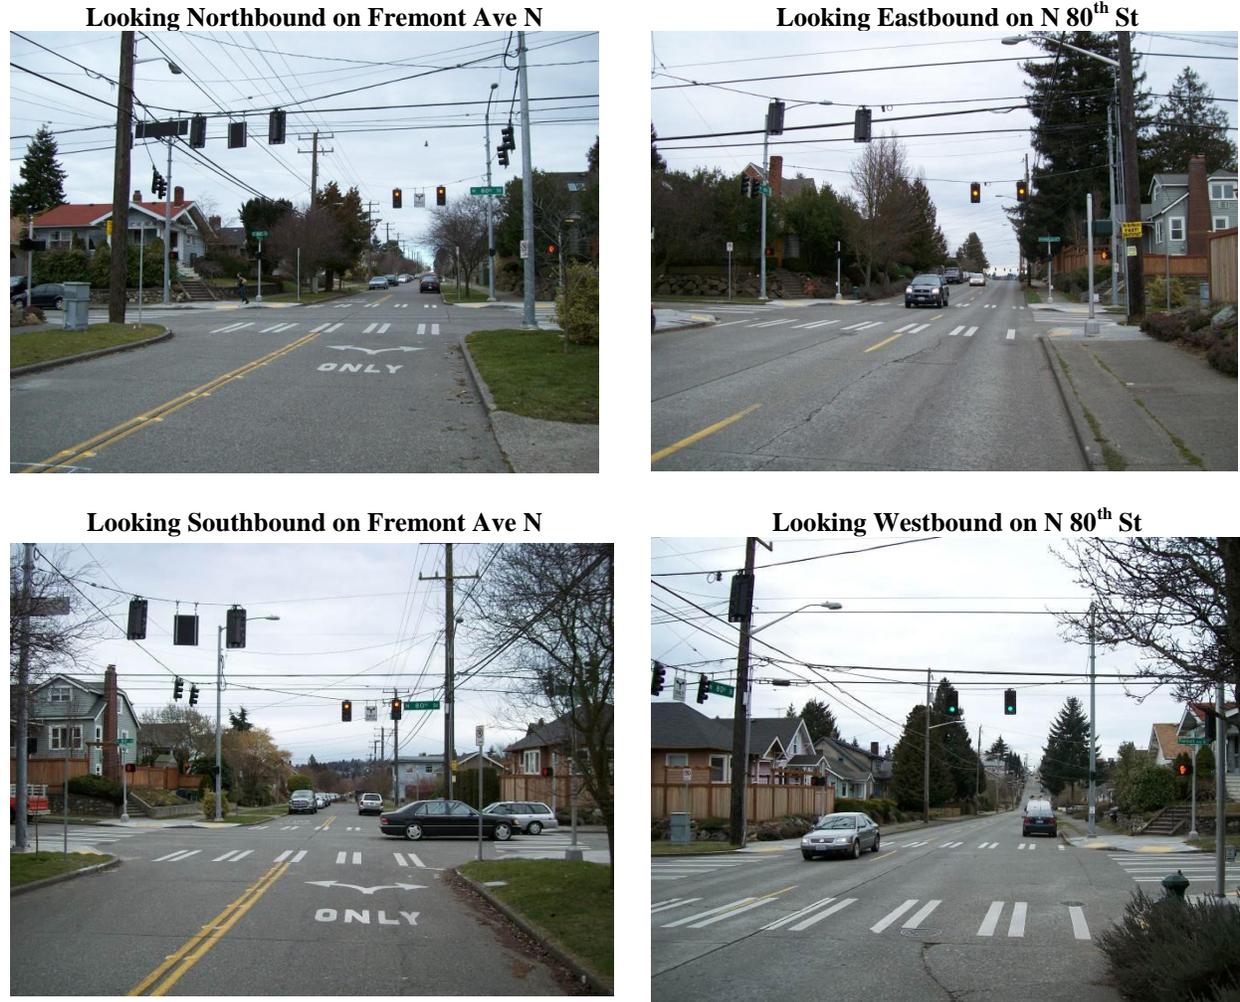
Figure 1. Photographs of Fremont Avenue N & N 80th Street

N 80th Street is an east-west arterial street with one lane of traffic in each direction. On-street parking is provided on the north side of the street. The traffic signal was turned-on on November

16, 2007. Prior to the installation of the traffic signal, Fremont Avenue N was controlled by a stop sign while N 80th Street had no control. See Figure 1 for photographs of the intersection.

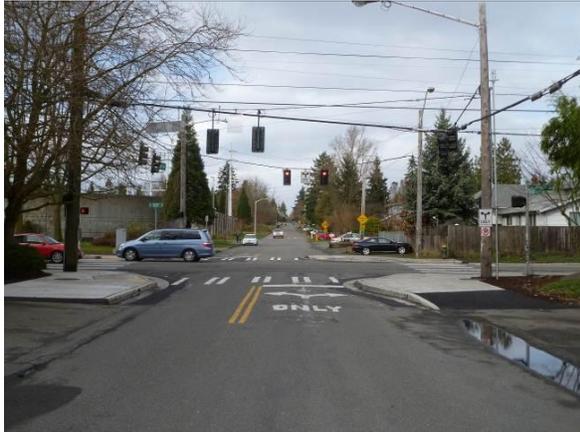
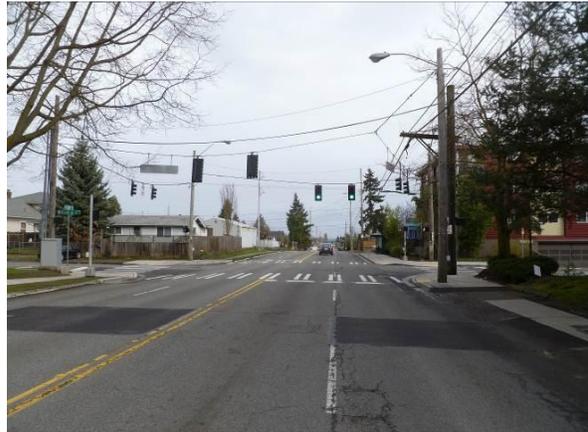
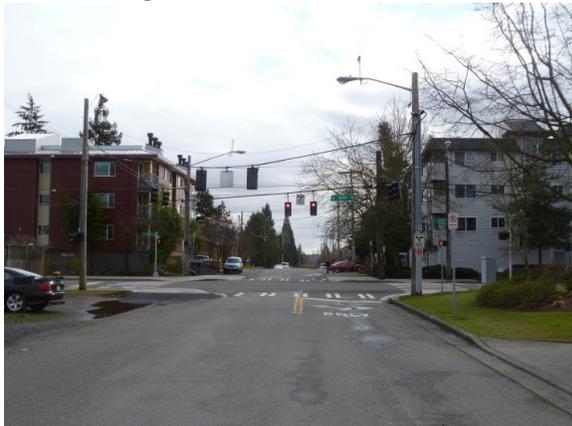
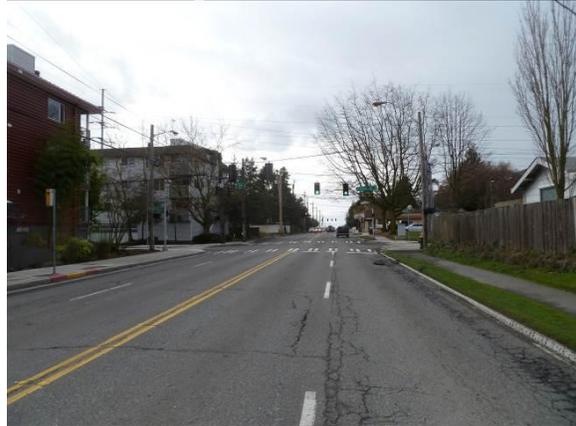
Figure 2. Photographs of Fremont Avenue N & N 105th Street

N 105th Street is an east-west arterial street with two lanes of traffic in each direction. There is no parking on either side of the street. The traffic signal was turned-on on October 7, 2010. As was the case with the N 80th Street intersection, Fremont Avenue N was controlled by a stop sign while N 80th Street had no control before the signal was installed. See Figure 2 for photographs of the intersection. Minor differences between this signal and that at N 80th Street includes the use of video detection for the side street instead of loop detectors and using the standard “hot spot” marking as described in Section 9C.05 of the MUTCD for bicycle detection. The signal at N 80th Street used a white T marking which was standard practice in Seattle prior to the release of the 2009 MUTCD.

Looking Northbound on Fremont Ave N

Looking Eastbound on N 80th St

Looking Southbound on Fremont Ave N

Looking Westbound on N 80th St

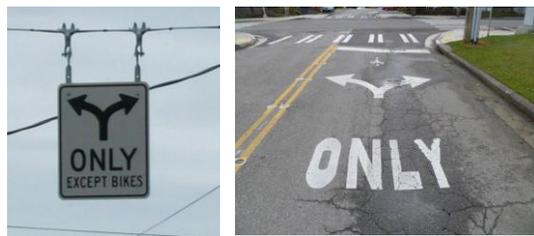
Figure 3. Turn Restriction Sign and Pavement Markings

The two traffic signals were designed as conventional four-way intersections. To prevent motor vehicles from using the route to bypass other arterial routes, motor vehicles were forced to turn either right or left at the intersection. These restrictions were conveyed to motorists using standard regulatory signs and pavement markings as shown in Figure 3.

As shown in the turning movement counts for both intersections, a substantial portion of motorists are violating the turn restriction sign and continuing straight through the intersection. Table 6 shows the number of side street motor vehicle through traffic versus the total motor vehicle approach traffic based on the 8 hour counts obtained following the signal installation at both intersections. While there were no apparent conflicts with bicyclists or pedestrians traveling through, these violations increase the cut-through traffic in the neighborhood.

4. Observations shows 12 to 14% of motor vehicles violate the crossing restrictions at both intersections. This is the only negative finding of this case study. A review of the collision records did not indicate any safety concern involving this, however, the violations may increase neighborhood traffic and complaints.

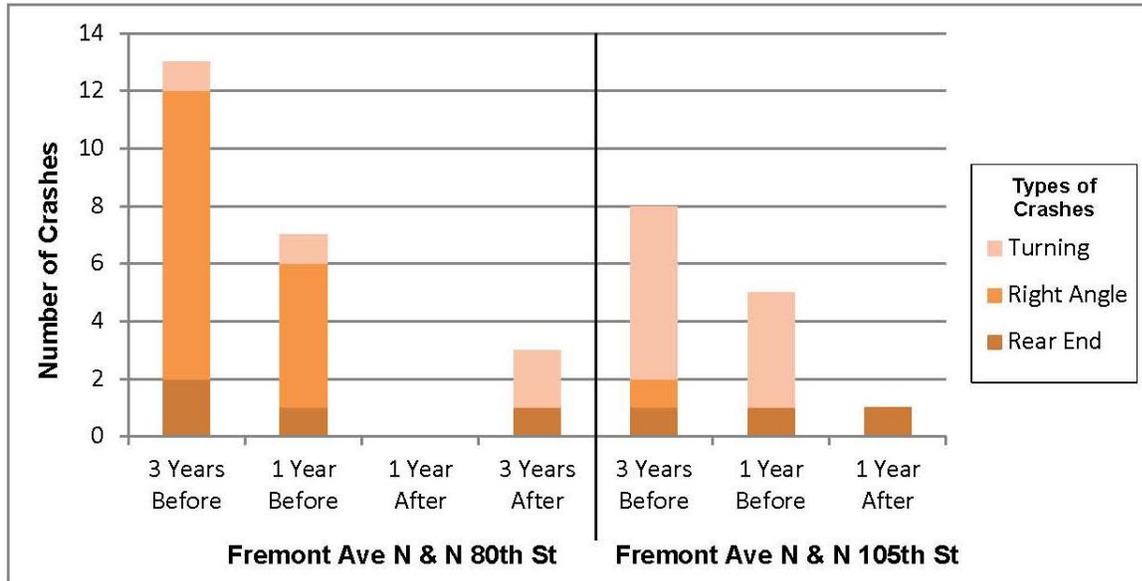
Figure 4. Collisions at Fremont Avenue N Intersections

A further breakdown of collision types was also done. These results are shown in Figure 4.

The results of the crash analysis show an overall reduction of crashes after the installation of the two signals. Table 3 below shows a summary of the crash analysis for the four intersections. Crash information was obtained from the Seattle Department of Transportation (SDOT) that included a 3-year crash history before installation and one to three year crash history after installation. To minimize the effect of construction activities on the analysis, a period of 6 months prior to signal turn-on date was excluded. Then, following the signal activation a 3-month period was excluded to allow roadway users to become accustomed to the signal. Table 3 summarizes the crash data obtained and classifies it based on whether the crash was correctable by a signal installation or non-correctable.
