In-Road Warning Lights: Revisiting Pedestrian Crosswalk Application

Faisal Hamood, Emelinda M. Parentela, Zaki Mustafa and Crystal Killian

This paper presents a case study on the condition of the in-road warning lights at the intersection of 25th Street and Moray Avenue in the City of Los Angeles, ten years after its implementation. The study addresses intersection safety, driver compliance, public opinion, and product evaluation.

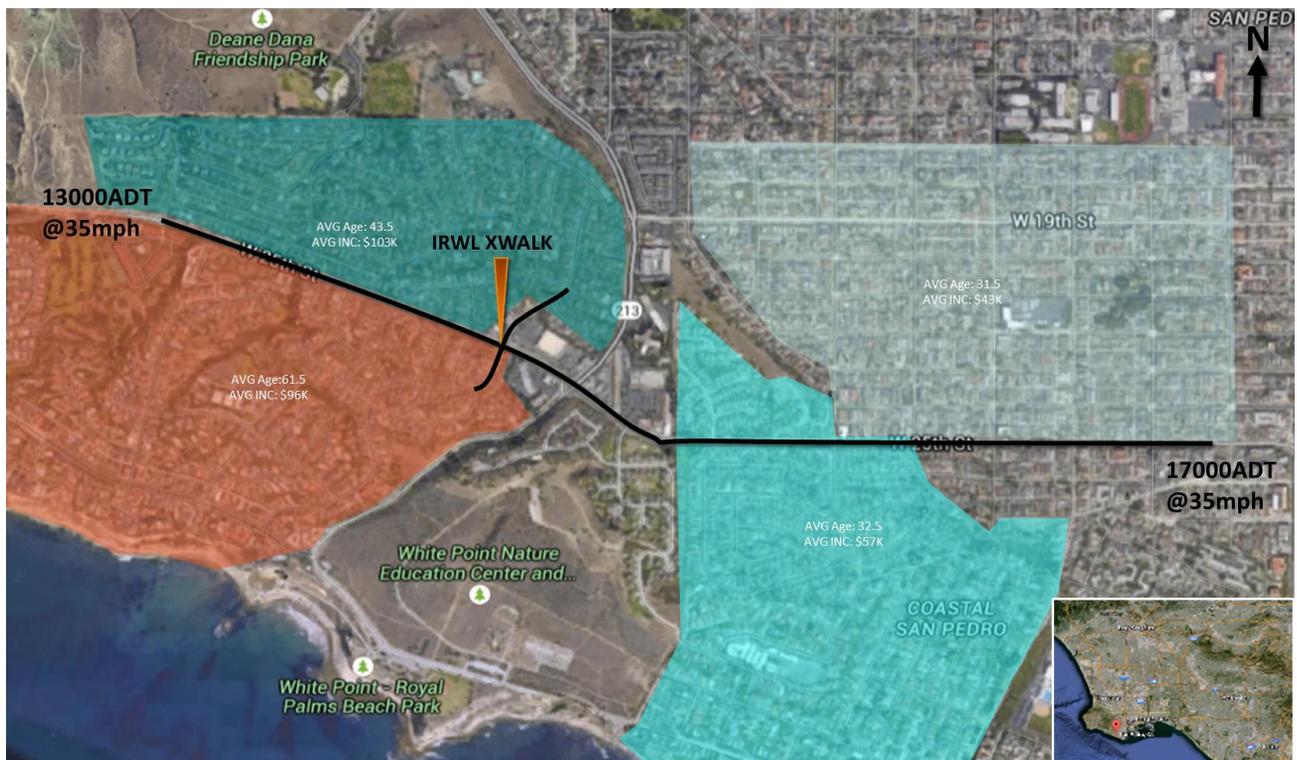
Figure 2: Crosswalk Location and Demographic [1]

This study evaluated a 10 year old crosswalk with IRWL in the Los Angeles area to identify the treatment’s successes and failures, outcomes, and safety recommendations for the region’s strategic plan. Figure 2 shows the location, traffic volume and speed limits, and average demographics of the area. Since compliance, and public opinion are key parameters, sociological data and location are important variables in understanding any results.

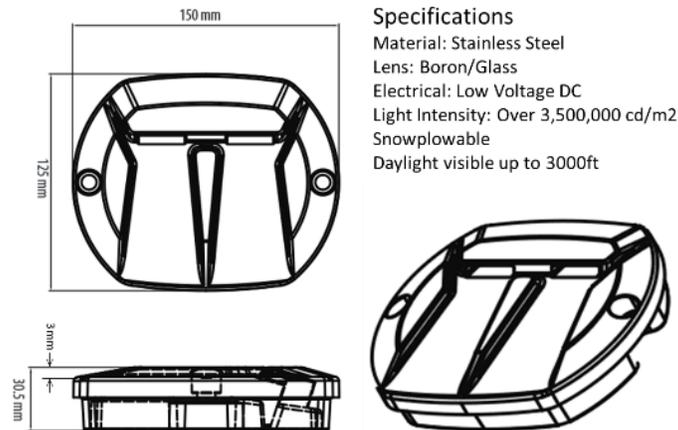
Figure 3: LaneLight Specifications [2]

For this location, LaneLights were used as the IRWL. Figure 3 section briefly introduces the product specifications for reference.

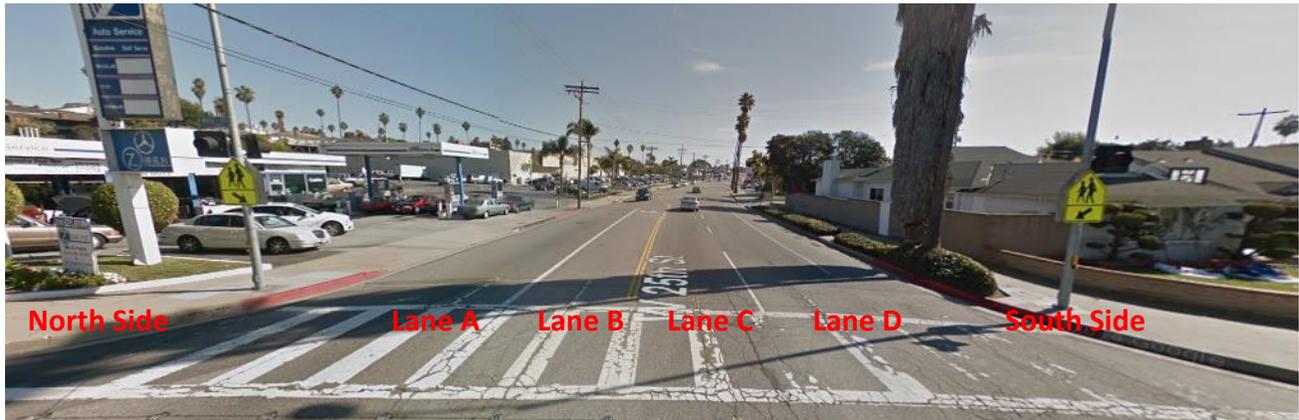
Figure 4: Lane Designation

Compliance data was collected by lane. Figure 4 shows the lane designation. When a system is activated on the north side compliance is recorded for all lanes including Lanes C and D. Similarly for the south side. Compliance is calculated using the equation below.

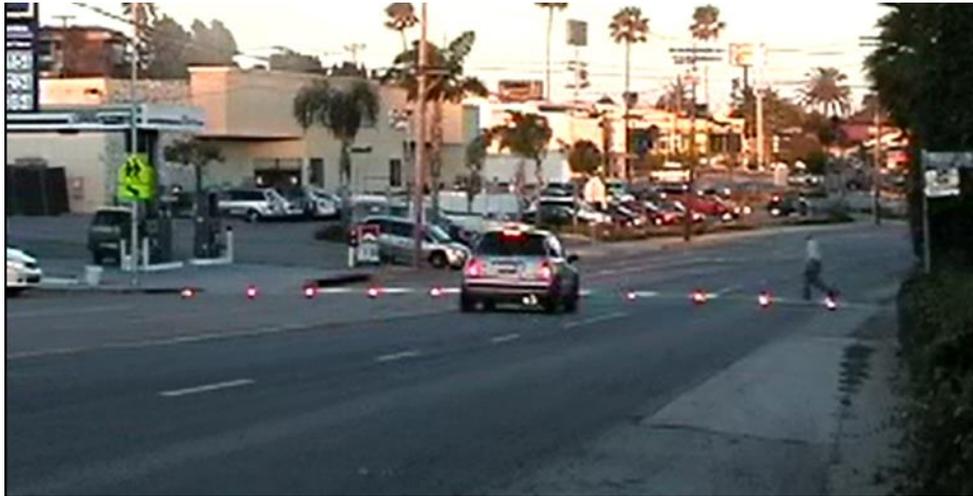
Figure 5: Crosswalk 2004

Product Reliability. LaneLights were initially installed in 2004 as shown in 5. Figure 66 shows the crosswalk 10 years later. Figure 7 shows the product’s timeline and replaced units. Six out of 28 units in total were replaced. The causes for replacement include dim lights, and burnt Light Emitting Diodes (LEDs). The original installation and replacements were performed by LADOT staff. The decision to upgrade the lights in 2014 was to increase life expectancy, and light output.

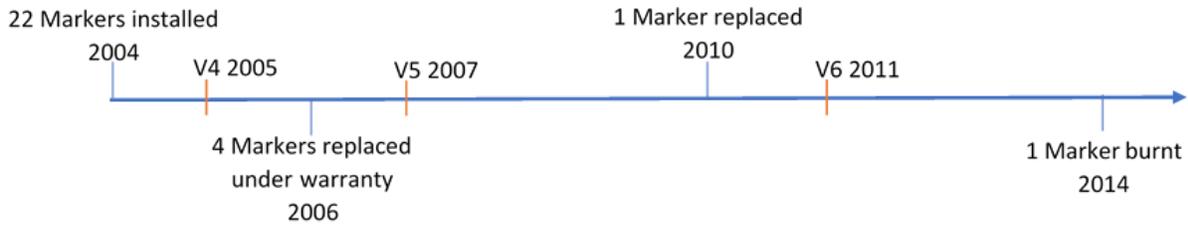
Figure 7: LaneLight Timeline

Version	Production Year	Mechanical	Electrical (W)	Photometric (LUX)
DCMLK150-V6	2014	N/A Control Unit	2.2W	
DCMLK150-V5	2010	Crushed wire. Lens OK. Structure OK.	2.5W	
DCMLK150-V4	2006	Lenses clear. Limited wire corrosion. Lens OK. Structure OK.	3W	
DCMLK150-V3	2004	Lenses clear. Wires crushed with limited corrosion. Lens OK. Structure OK.	3W
