## **2026 ITE Western District Annual Meeting**

Harnessing AI for Traffic Safety:  
Near-Miss Analysis for Newhall Avenue  
Railroad Crossing Improvement

Newhall Avenue Railroad  
Crossing Improvements Project

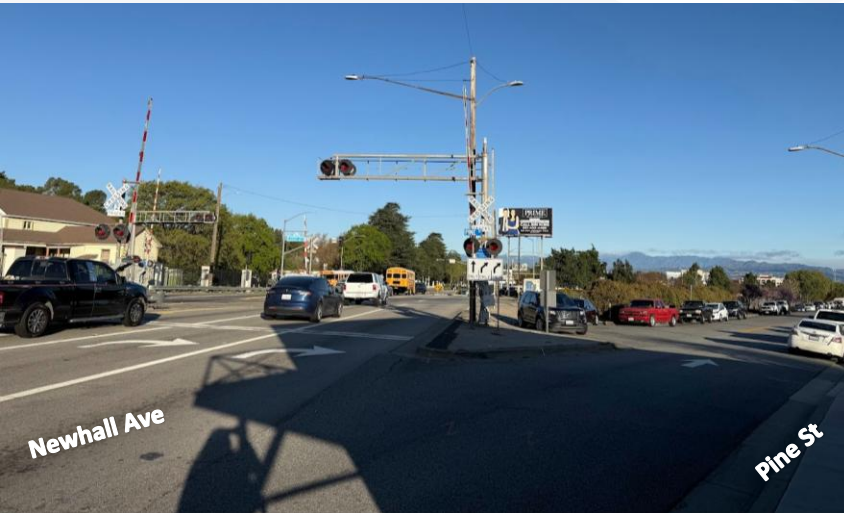
*Westbound Approach of Newhall Avenue At-Grade Crossing*

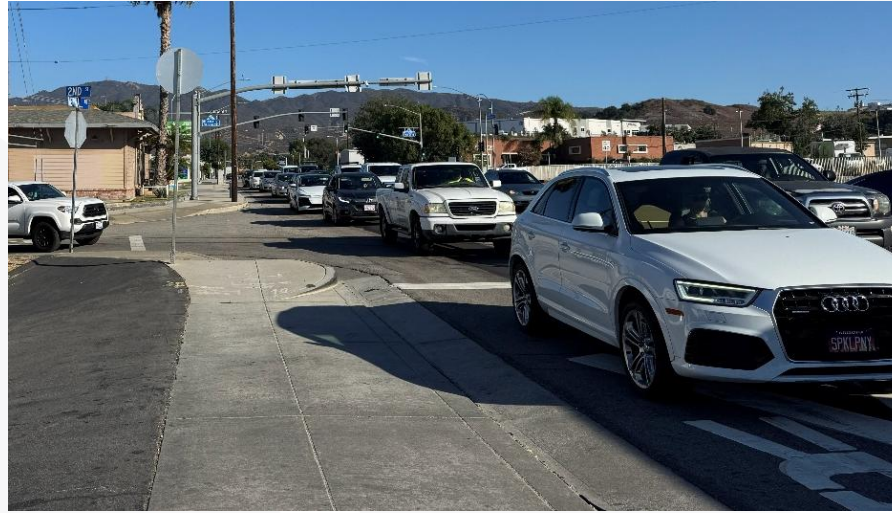
*Westbound Queue along Newhall Avenue*

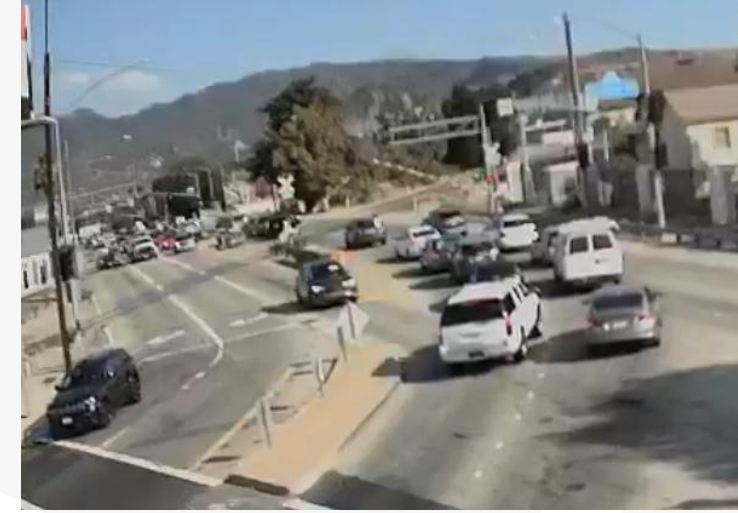
*Eastbound Queue Spillback at Newhall Avenue Railroad Crossing*

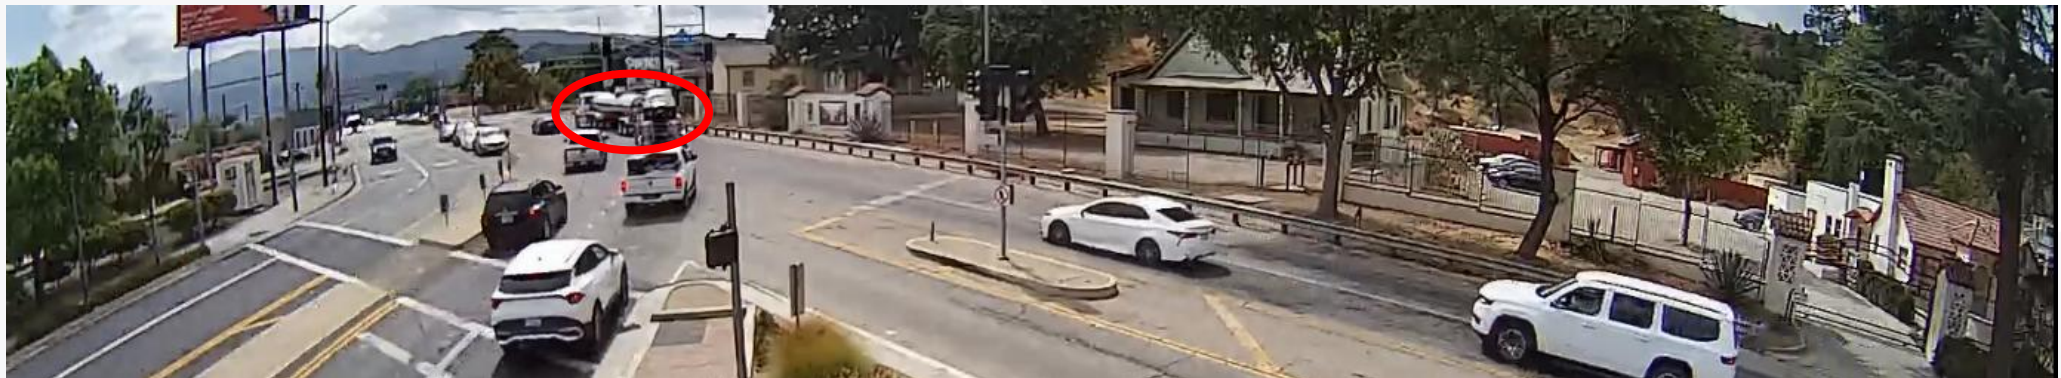
*Southbound/eastbound truck comes to a full stop in advance of railroad tracks after turning left from Railroad Avenue onto Newhall Avenue*

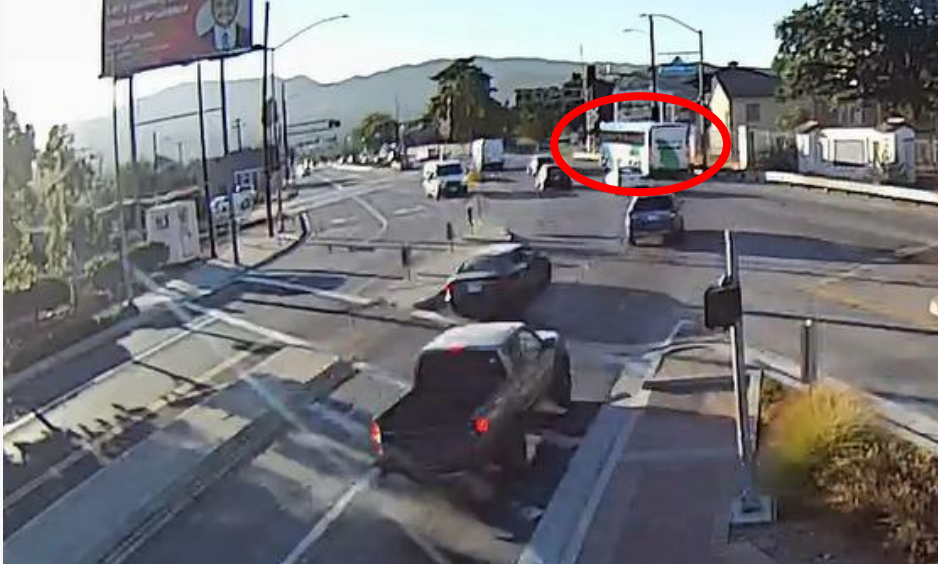
*Southbound/eastbound Santa Clarita transit bus swinging wide to the rightmost lane, leaving room for two lanes of vehicles to travel through the intersection*

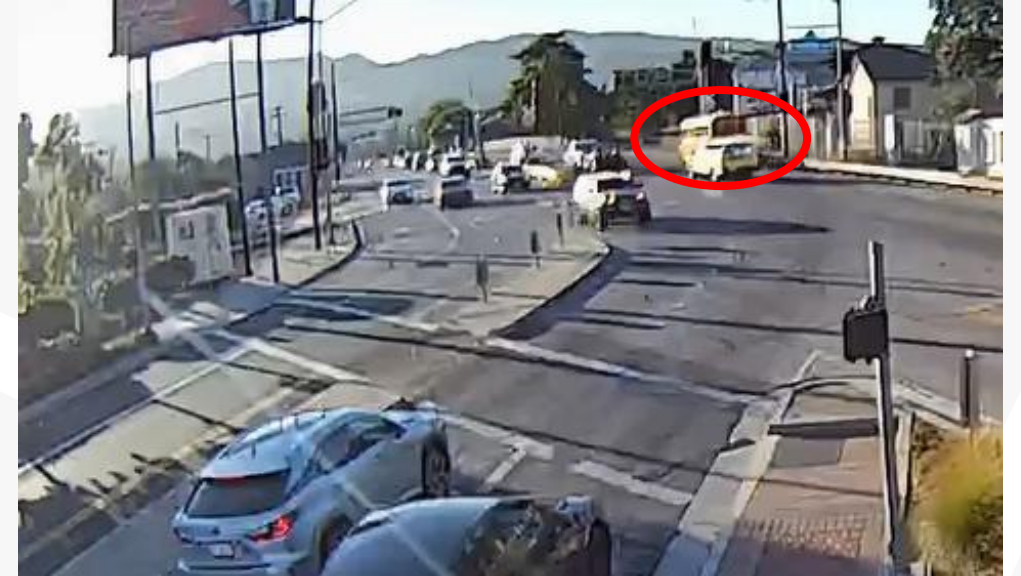
*Eastbound school bus stopping in the rightmost eastbound lane, leaving room for two lanes of vehicles to travel through the intersection*

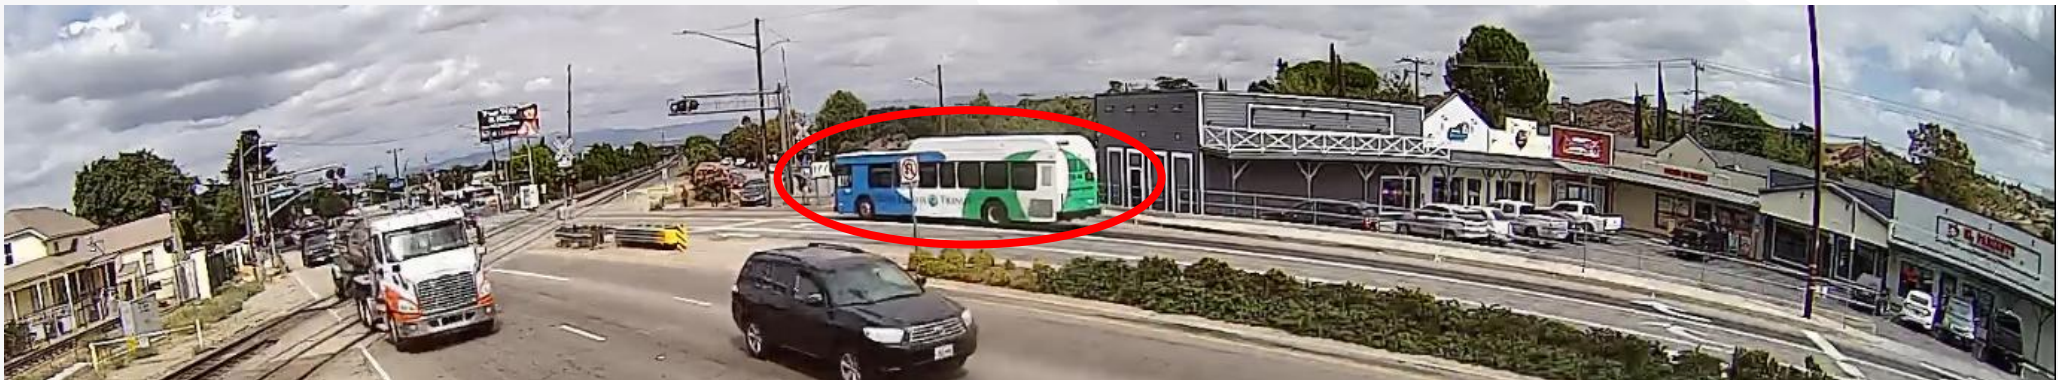
*Westbound bus comes to a full stop in advance of railroad tracks along Newhall Avenue*

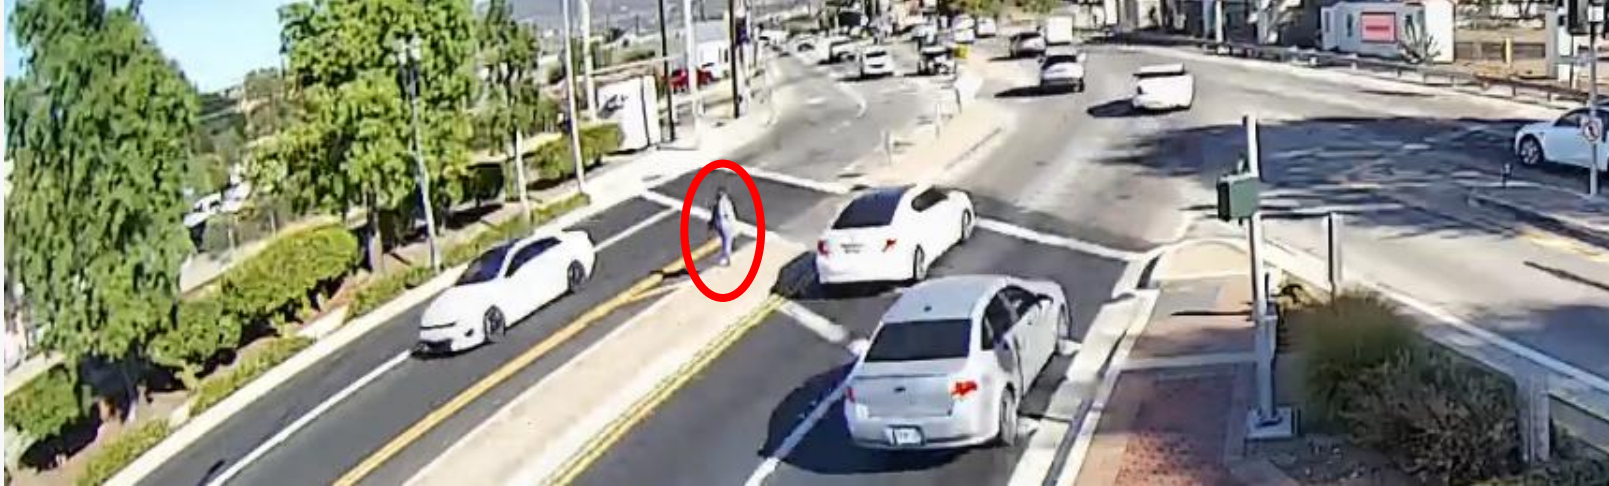
*Pedestrian using the median island as refuge while waiting to cross Railroad Avenue outside of pedestrian phase*

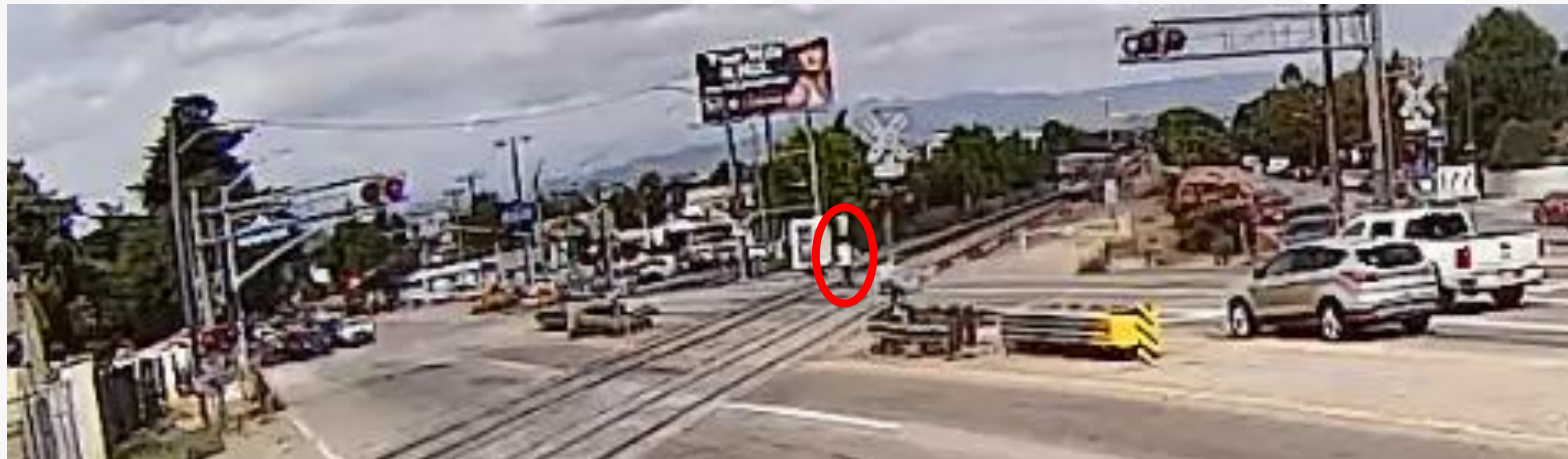
*Pedestrian on scooter navigates around closed train barriers traveling westbound on the north side of Newhall Avenue*

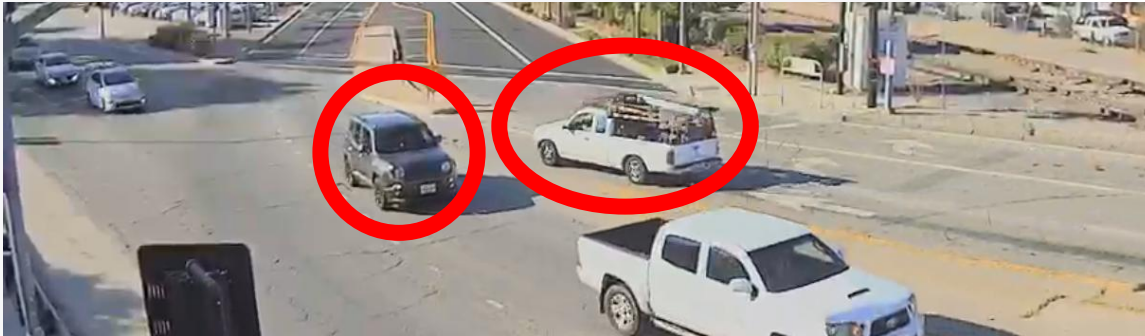
*Eastbound Newhall Avenue queues back up to the study intersection, with a westbound vehicle nearly missing a southbound vehicle queued in the intersection*

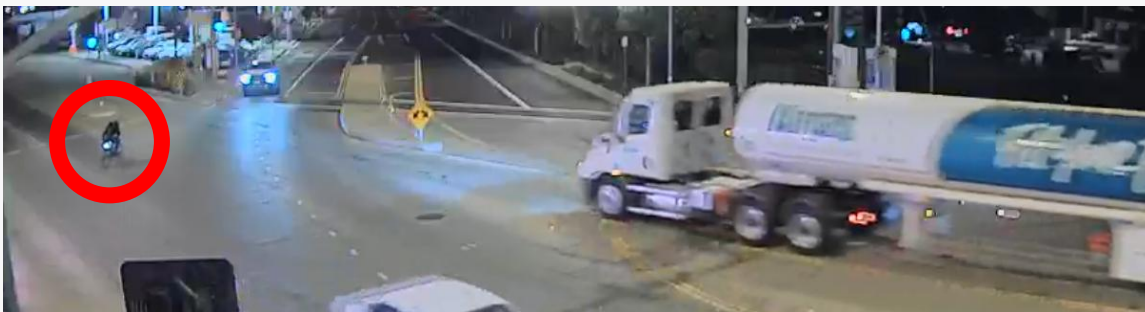
*Southbound cyclist runs a red light, nearly missing eastbound and westbound through vehicles*

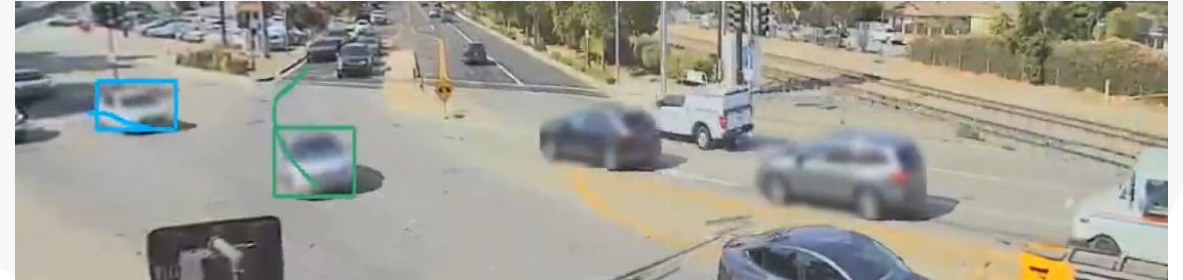
*Southbound vehicle runs a red light at the end of green, nearly missing an eastbound vehicle*

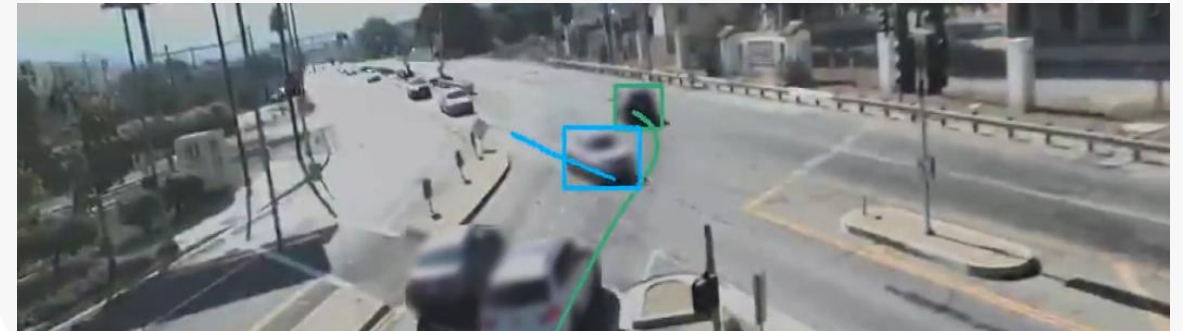
*Westbound vehicle runs a red light at the end of green after southbound traffic has started moving*

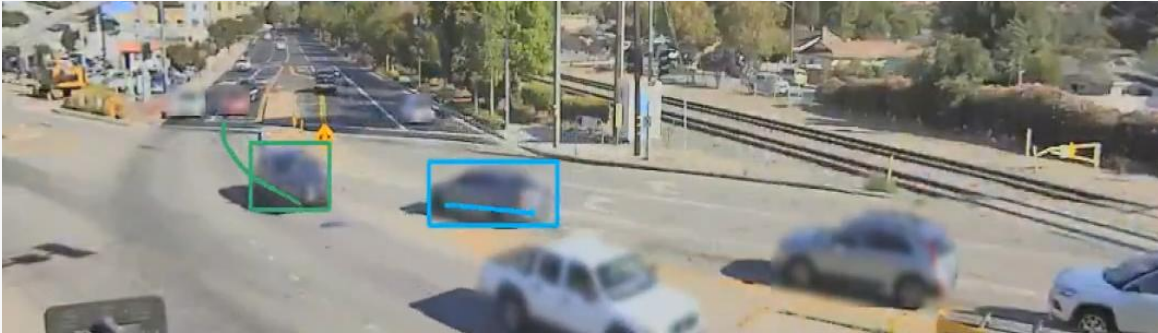
*Southbound vehicle runs a red light at the green cycle*

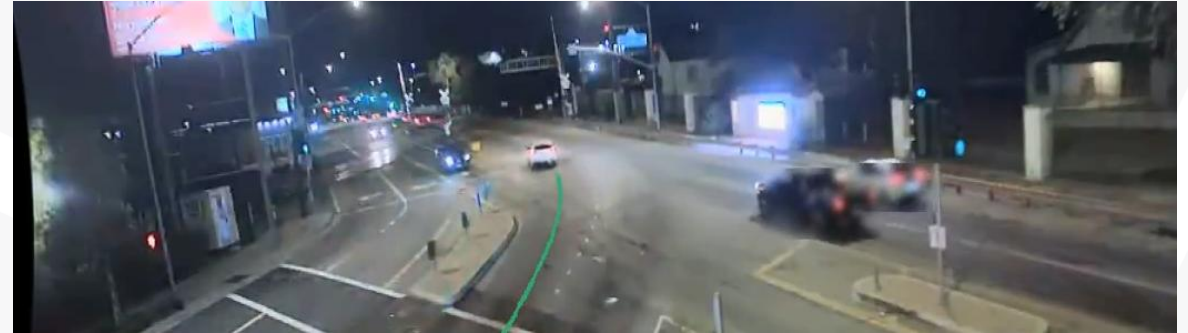
*Southbound vehicle runs a red light at the end of green cycle*

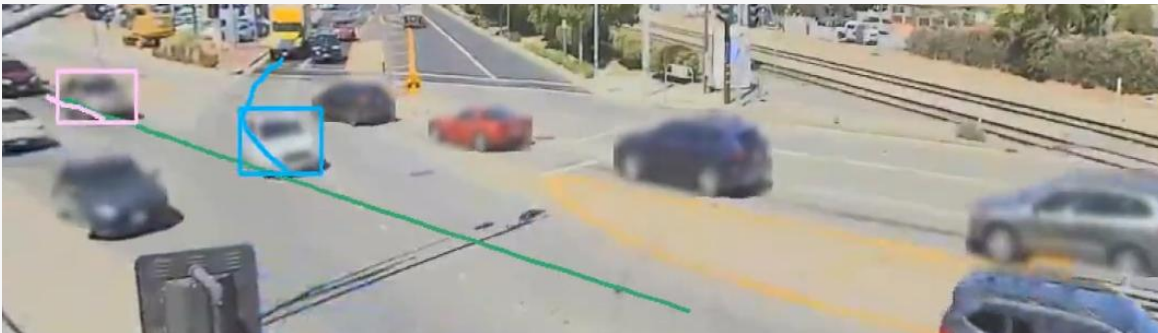
*Southbound vehicle runs a red light at the green cycle*

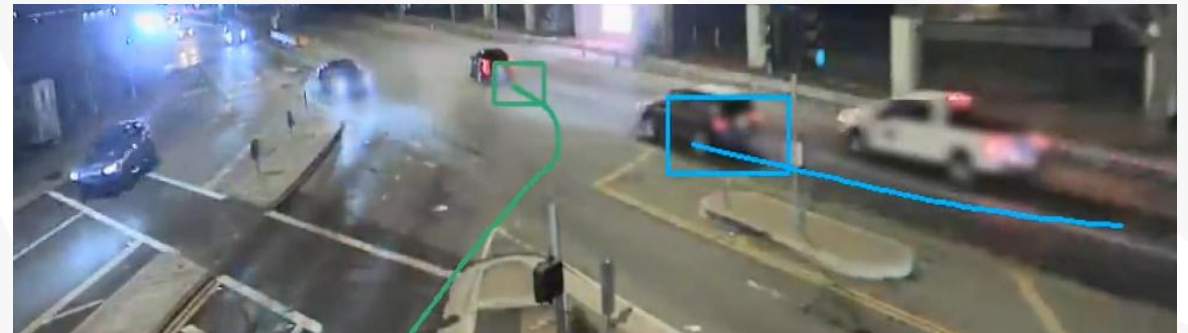
*Southbound vehicle runs a red light after westbound traffic has started moving*

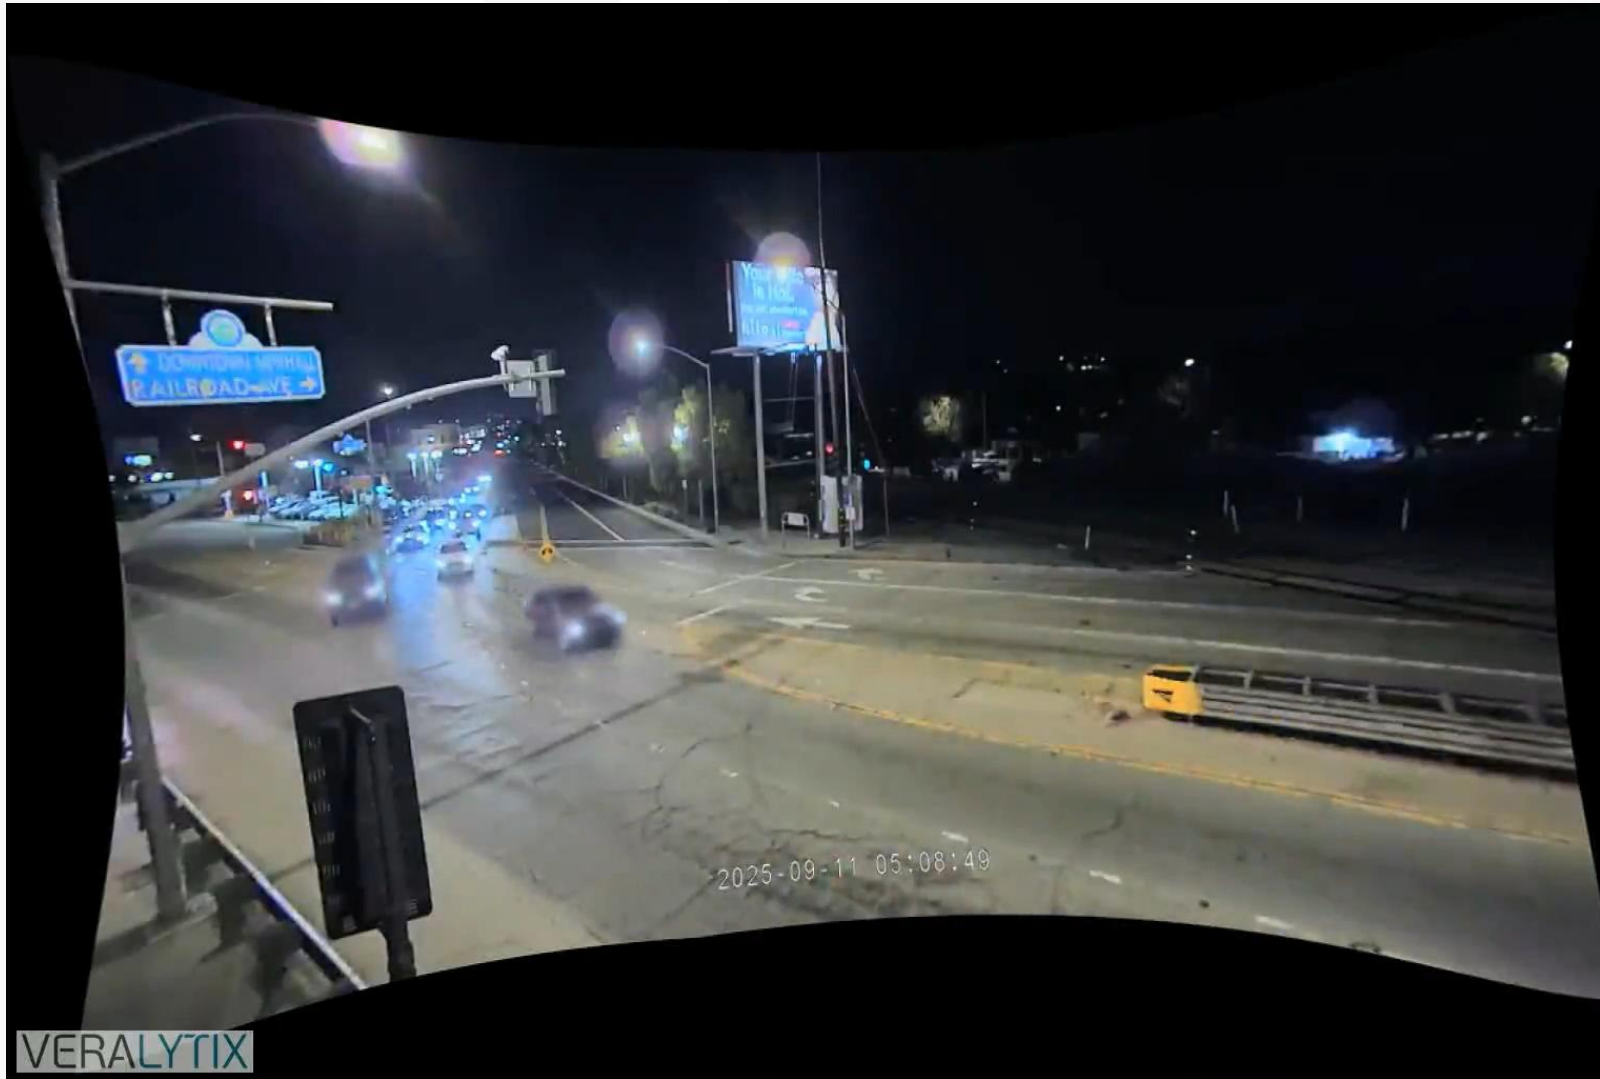
Conflict time:  
2025-09-11 05:08:52  
Conflict:  
Adjacent-Approaches  
PET: 0.93 s  
Delta-V: 2.17 MPH

Direction:  
Southbound Left  
Speed:  
15.84 MPH  
User Type:  
Passenger Car

Braking Distance:  
10.71 Feet

Direction:  
Eastbound Through  
Speed:  
20.05 MPH  
User Type:  
Passenger Car

Braking Distance:  
17.15 Feet
